TECHNICAL REPORT
NATICK/TR-82/029

AN EVALUATION OF THE PROPOSED MARINE CORPS EXPEDITIONARY FOOD SERVICE SYSTEM CONCEPT

JANUARY 1982

UNITED STATES ARMY NATICK RESEARCH & DEVELOPMENT LABORATORIES NATICK, MASSACHUSETTS 01760

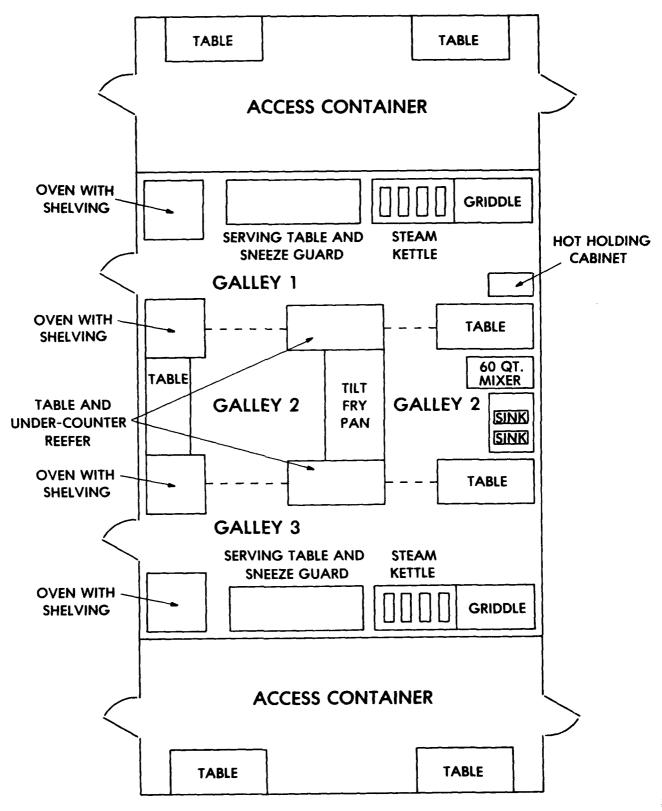
FIGURE 13: RECOMMENDED EQUIPMENT CHANGES

- 4. The equipment sampling data, and the cook's comments on the steam cooker, (for example, "its too small") forces us to recommend their removal from the equipment list of the ISO galley complex. This will provide an even greater availability of power for galley 2 as shown in change #5.

- 6. The maximum number of patrons fed at any one A-ration meal during the test was 690. During the preparation for this meal, all major items of cooking equipment were sorely taxed. It is envisioned that the galley could not prepare an A ration meal for 1000 men without considerable menu modification. This is especially true for the breakfast meal. Therefore, it is recommended that two ovens be added to galley 2 and to expand the production capabilities of the ISO galley. The effects of these two ovens on power is shown in change #7. One table can be eliminated from the inventory and the two ovens put in its place.

- 2. Change #3 replaces the current coffee urns in galley 1 and 3 with one that draws considerably less power, the Bunn-O-Matic RL35, thus making more power available to galley 1 and 3 for additional equipment changes. The Bunn-O-Matic RL35 coffee maker is a 5 pot (10 cups per pot) system that can provide a pot of coffee every 3 minutes.
- 3. By adding one more well to the three-well steam kettles, as presented in change $\#^{\downarrow}$, two benefits results. First, during A-ration meals, the menu sometimes consisted of one entree, two vegetables, and a starch, or one entree, gravy, a vegetable, and a starch. A four-well kettle on each line will aid in maintaining the temperatures of these items which will then appear more appetizing to the customer. Second, a fourth well will provide some of the additional capacity required for preparing a meal for 1000 men.

- 7. To reduce the amount of time spent going to and coming from the ISO reefers placed outside the galley complex, it is recommended that two under-the-counter-reefers be put inside the galley for storing those food items needed at the next meal. This will reduce the labor and time required to obtain stores from the reefers. The power required for these reefers is shown in change #8.
